TRECOM TECHNICAL REPORT 64-9

**COMPILATION AND ANALYSIS OF TEST DATA
ON FIBERGLASS-REINFORCED PLASTICS**

March 1964

**KAMAN AIRCRAFT CORPORATION
Bloomfield, Connecticut**

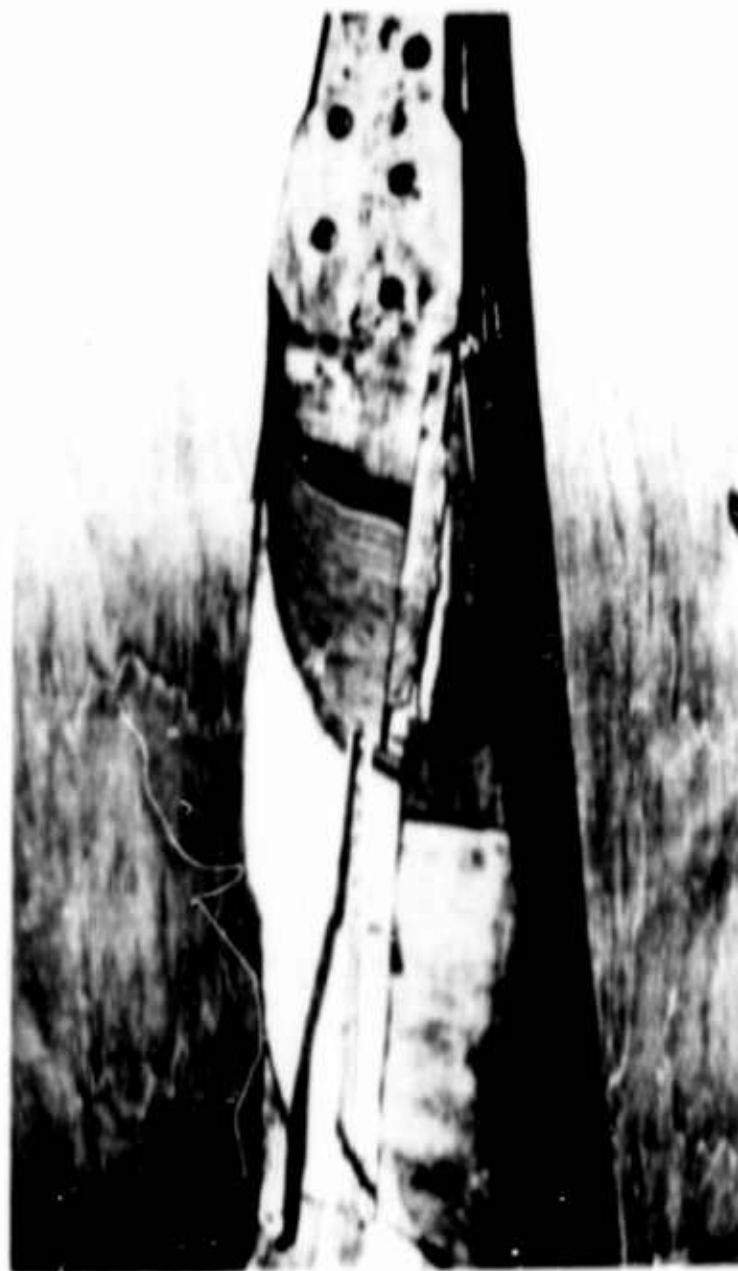
Figure 11-7. Original Stub Configuration Showing General Failure

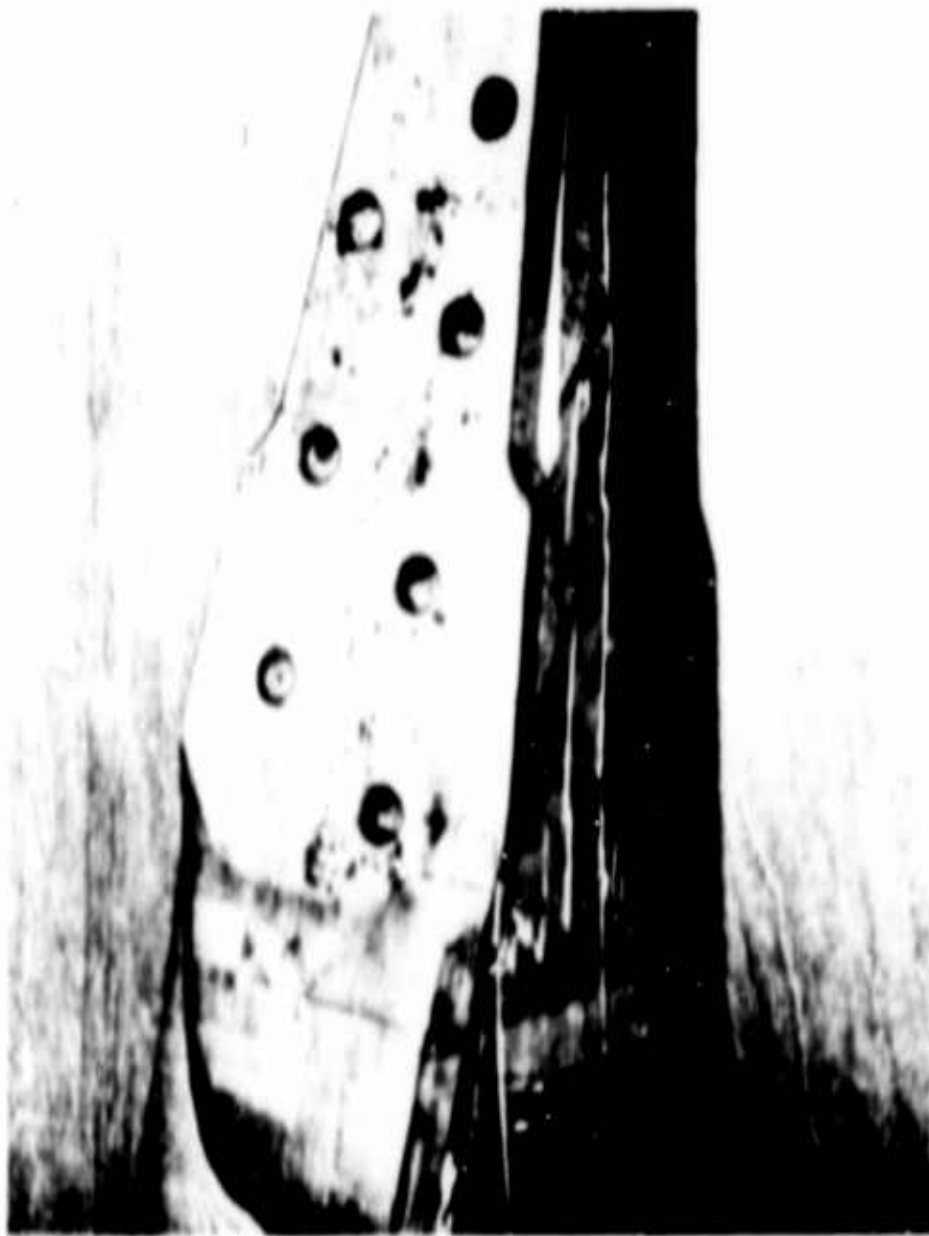
Figure 11-8. Close-up View of Stub Failure

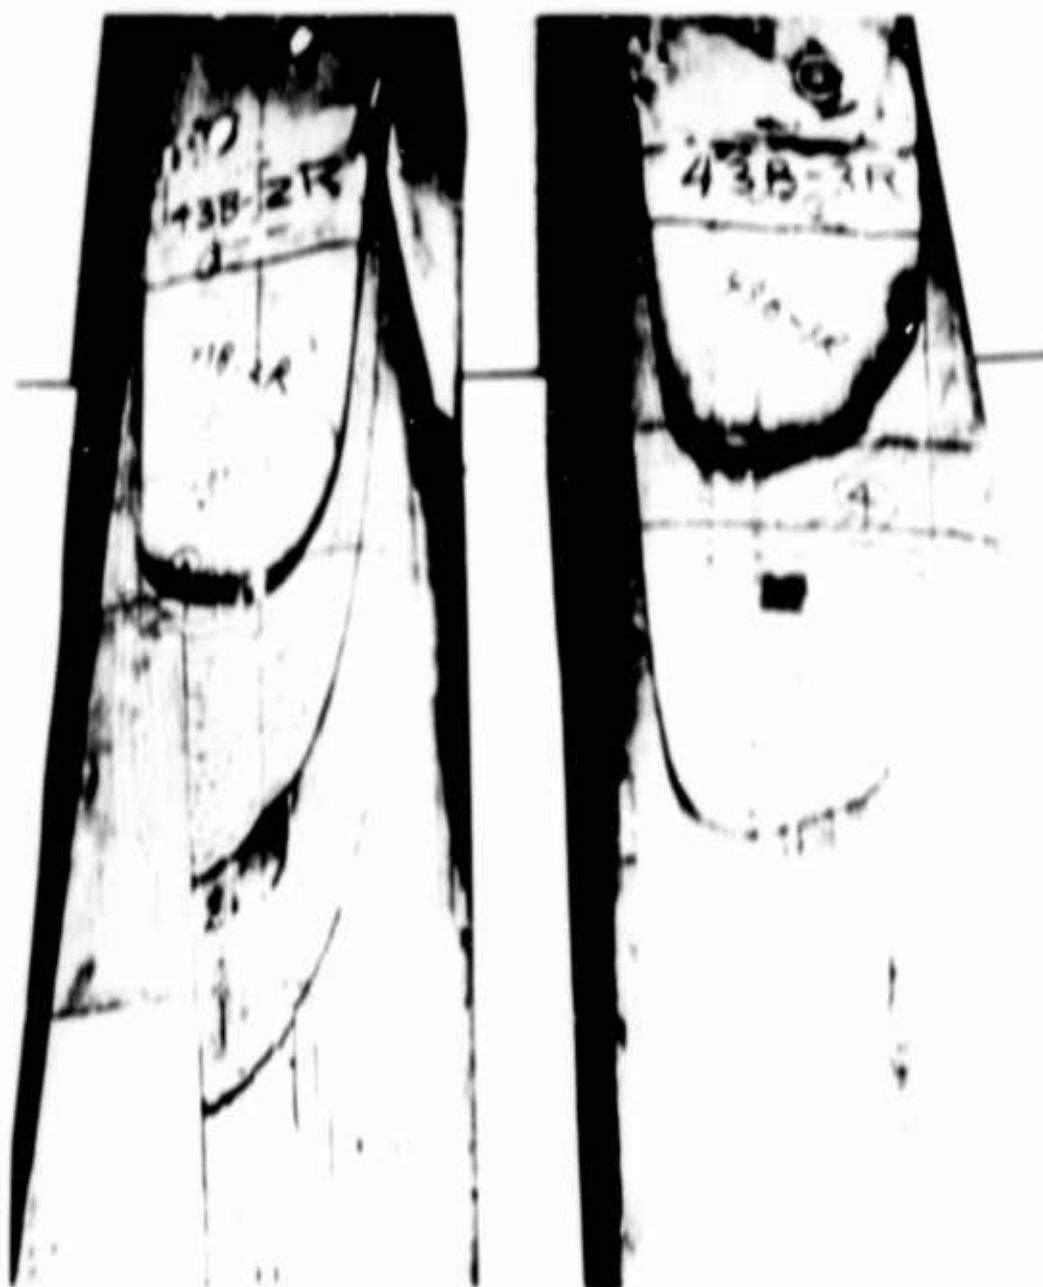
Figure 11-10. View Showing Failure of Static Test Stub

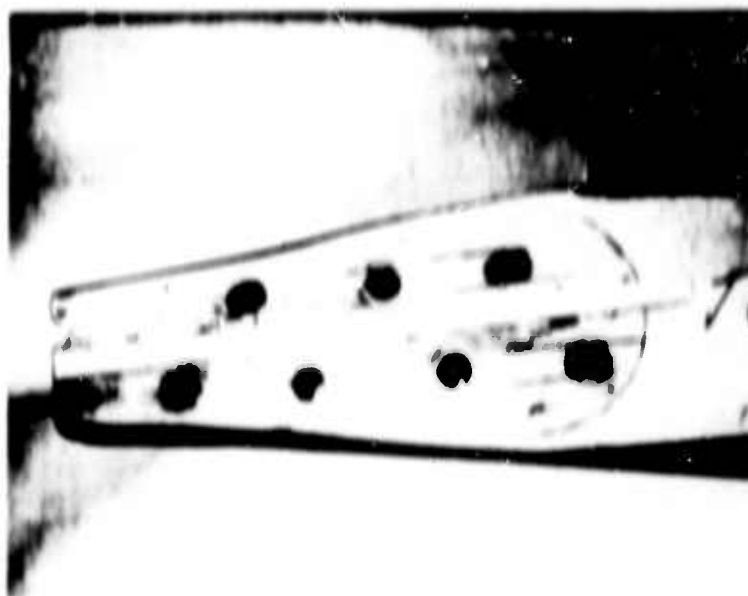
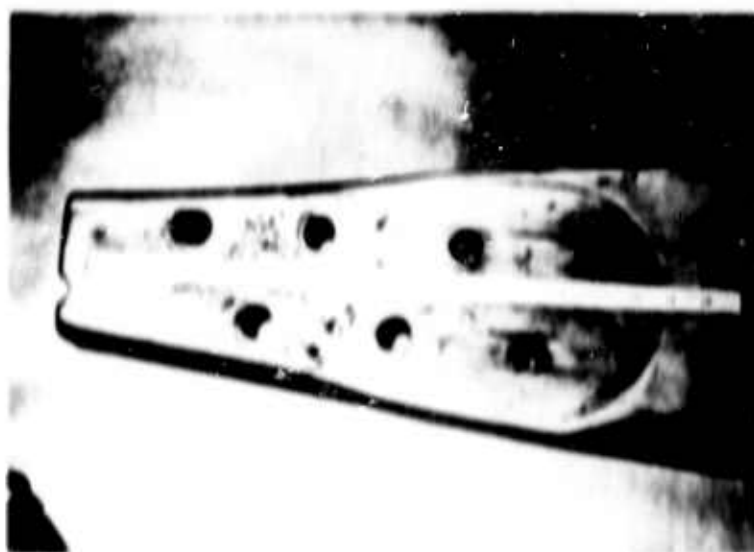
Figure 11-43. Spanwise Cracks in Upper and Lower Grip Facings

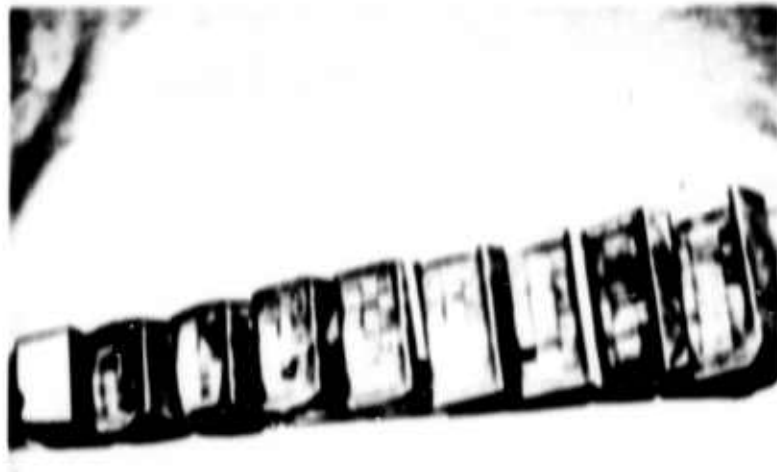
Figure 11-44. Blade Root-End Crack Propagation

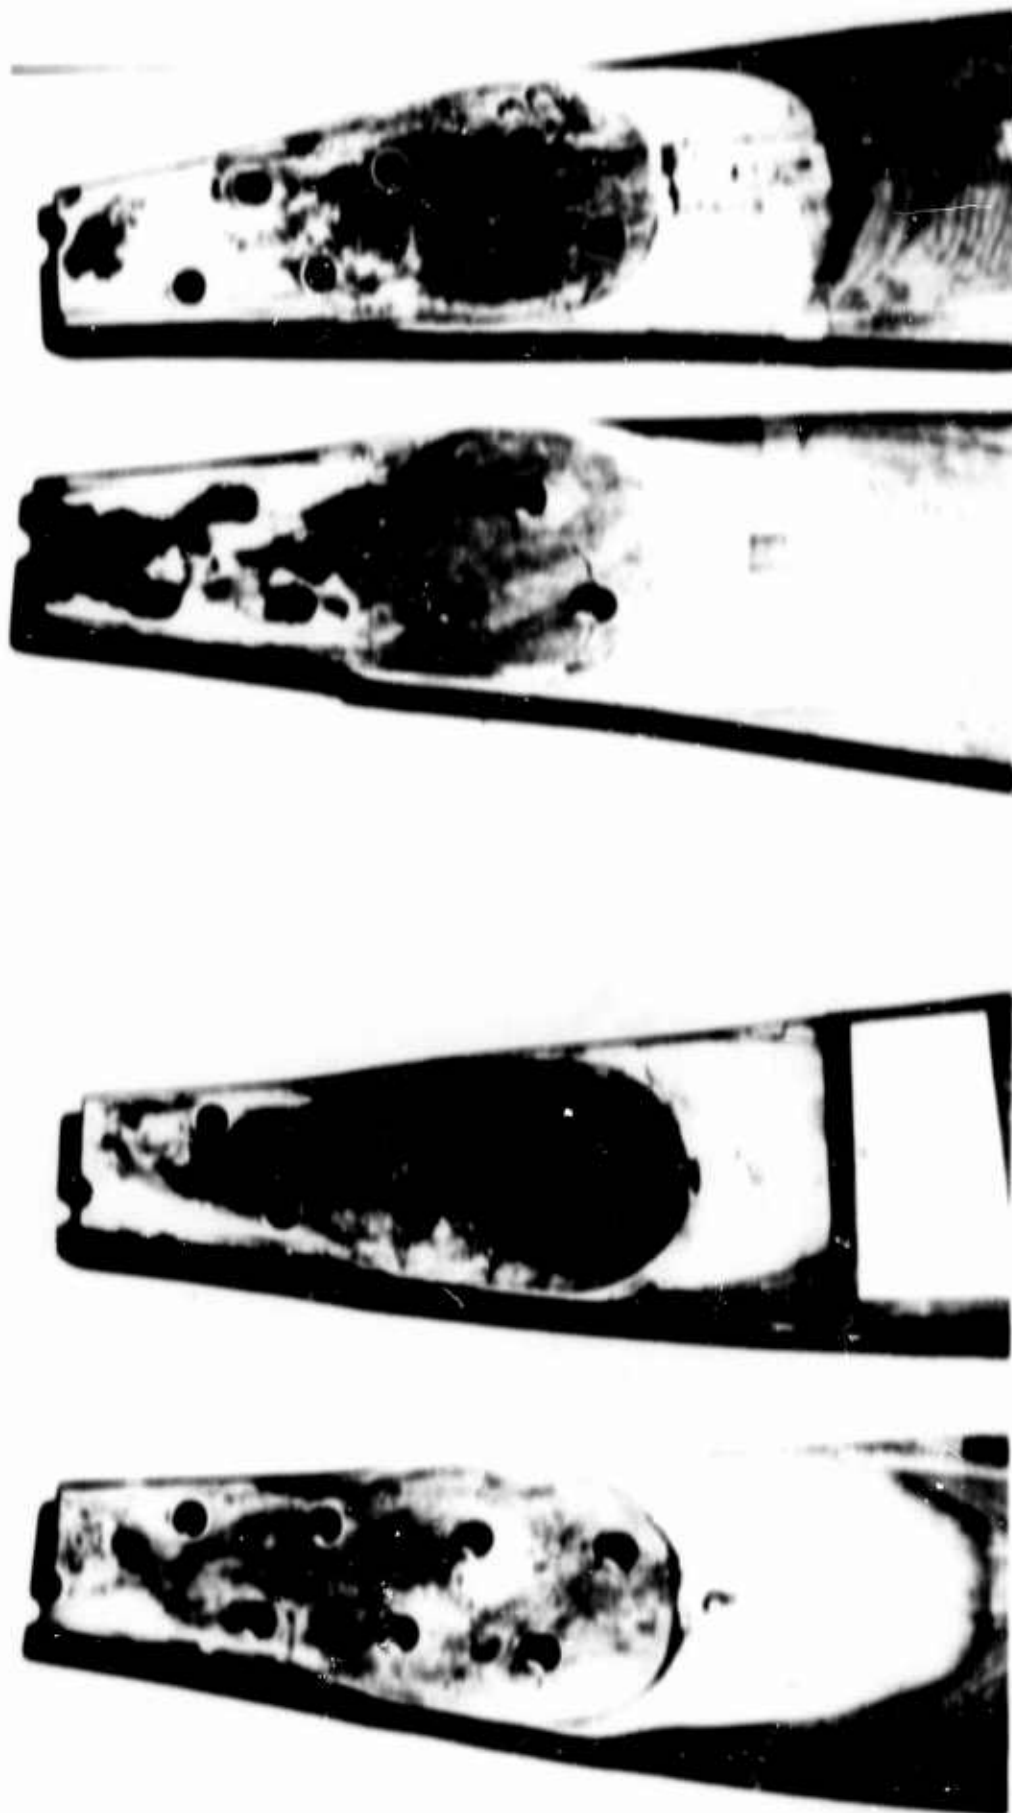
Figure 11-45. Blade Root-End Specimen Damage

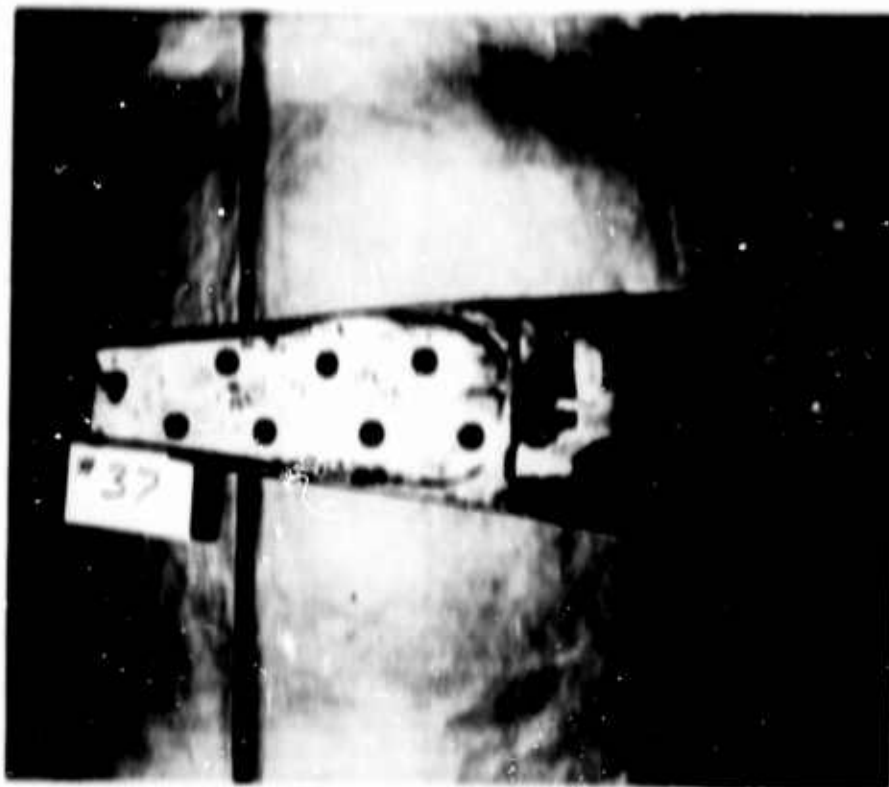
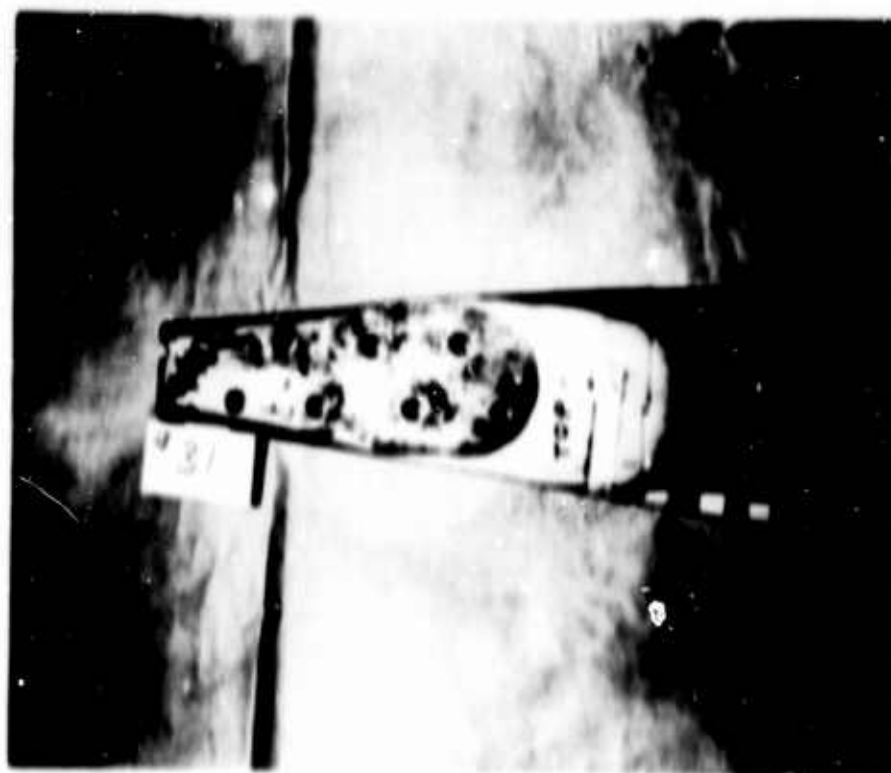
Figure 11-48. Blade Root-End Spanwise Cracks

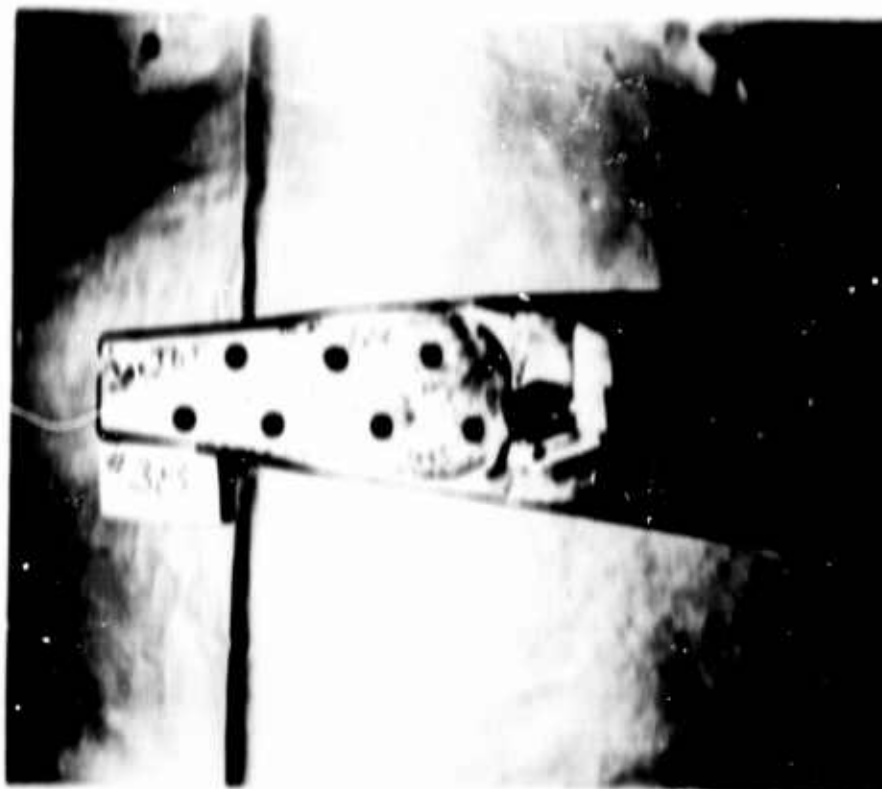
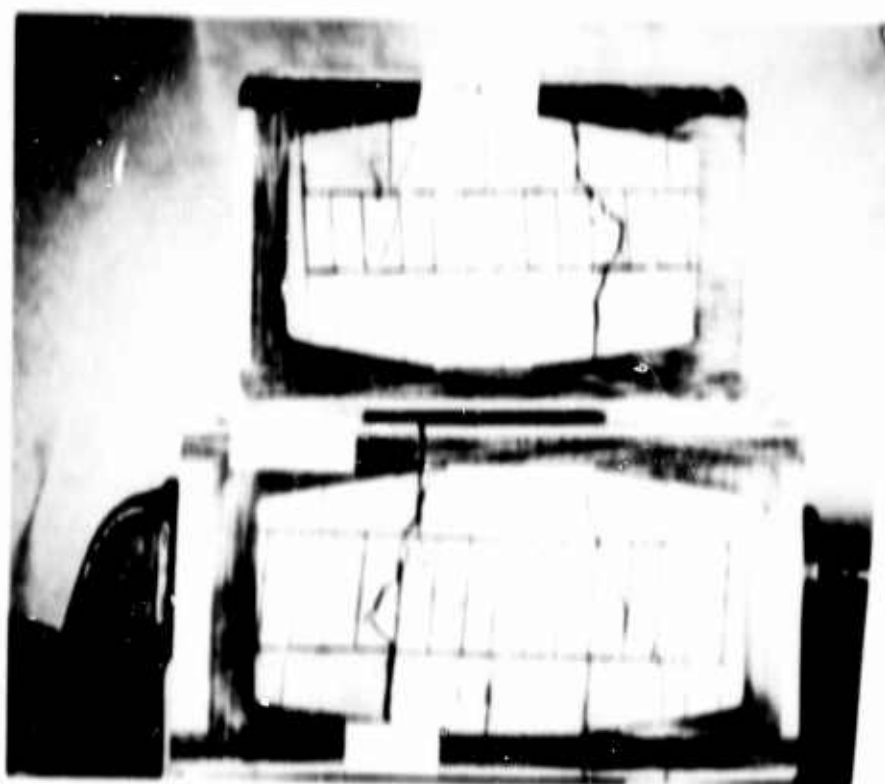
Figure 11-48. Blade Root-End Spanwise Cri

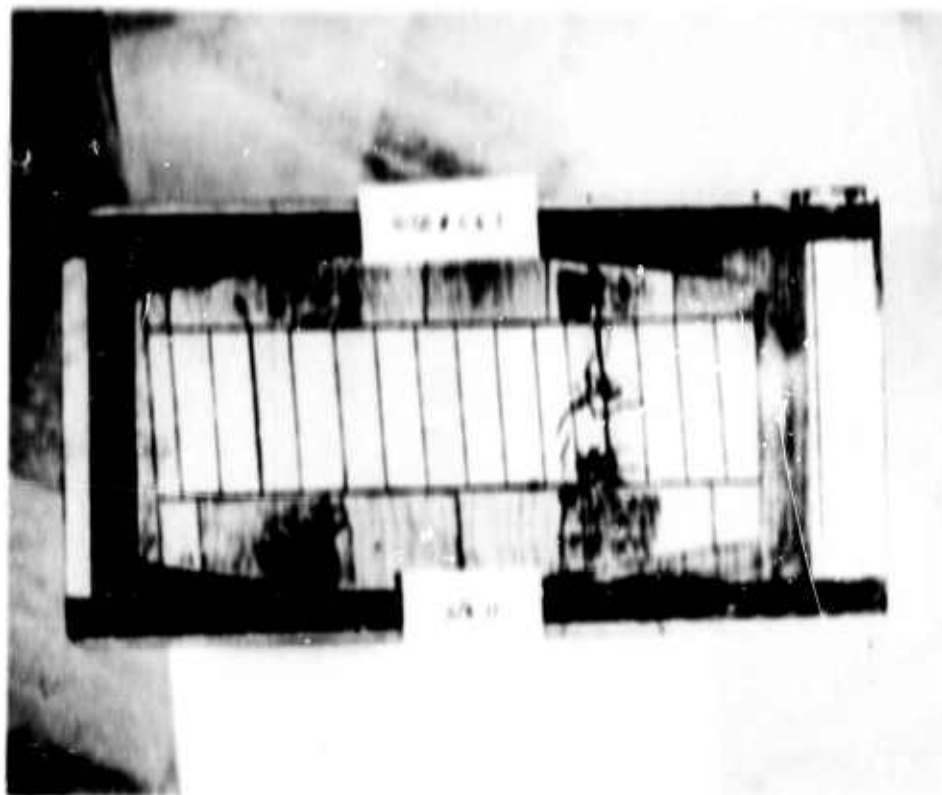
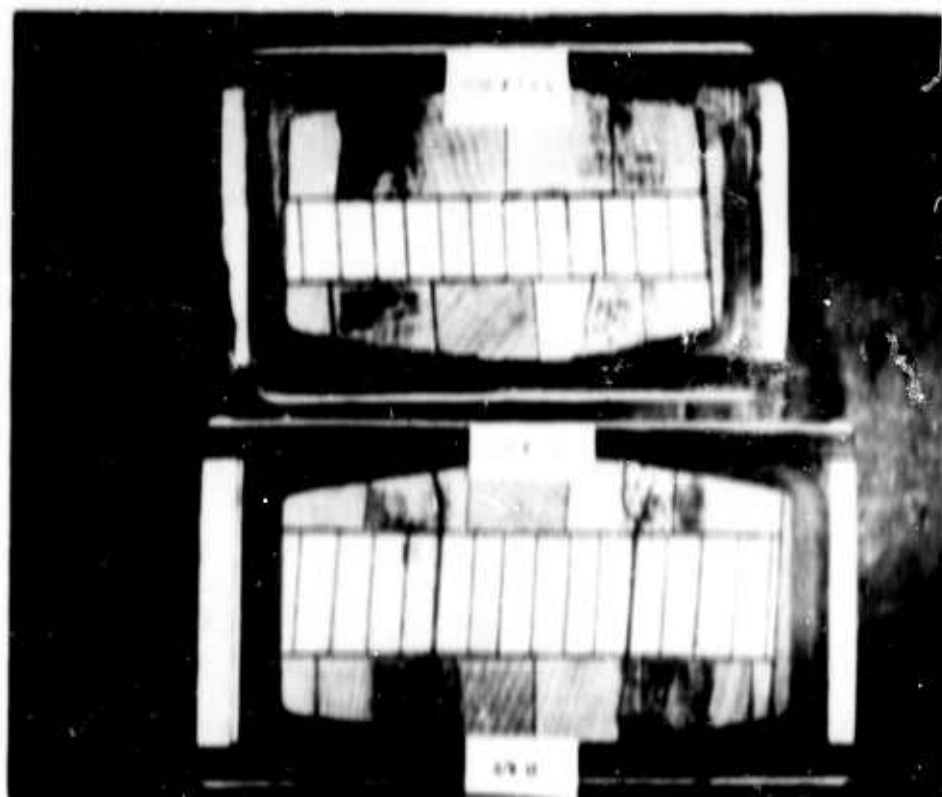
Figure II-50. Epoxy Filled Spanwise Cracks

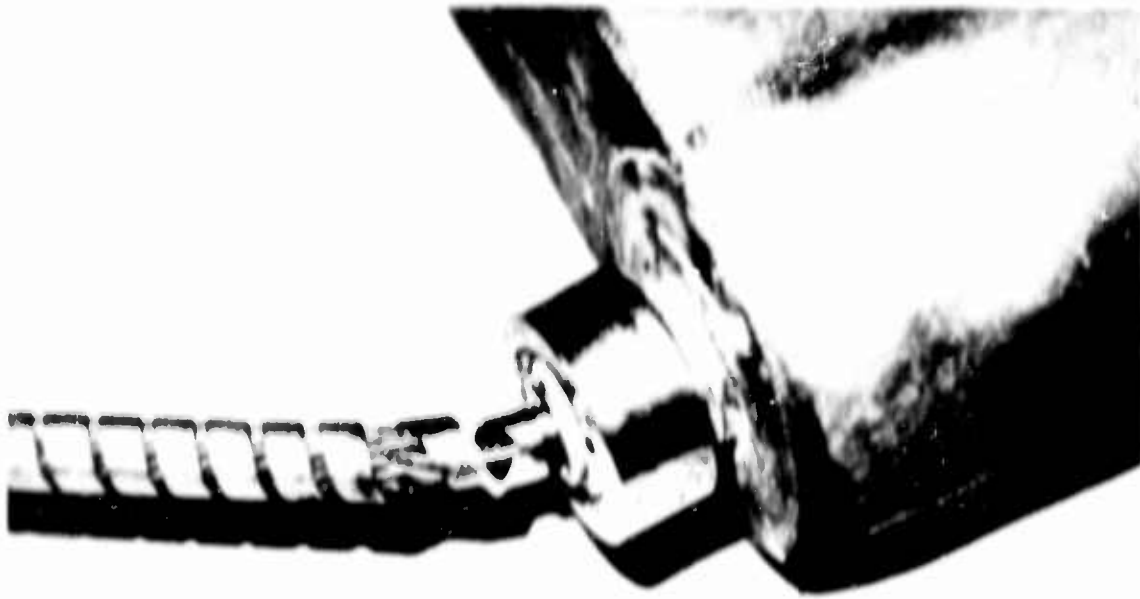
Figure VI-11. View of Flap Cable Failure
